CAL-TRANS TEST REPORT

"TIRE LIFE EXTENDER"

**ULTRA
SEAL**
TIRE
SEALING
PROCESS

**ULTRA*SEAL
INTERNATIONAL INC.**

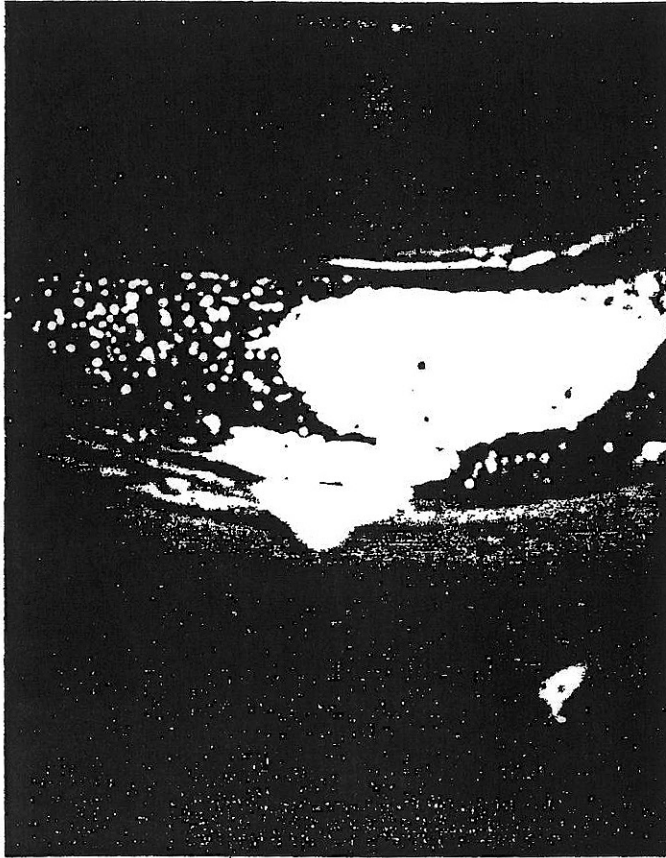
Truck # 1

L/R tire went flat overnight and was removed. Inspection showed a cut approximately 1 1/2" in length in tread area. An additional 8 fl. oz. of product was applied and tire inflated to 45 lbs. Bouncing tire on ground stopped air loss and tire was placed back on truck.

Overnight, L/R tire went flat. Inspection at Chuck's Tire showed cut 1 1/2" on inside of tire as well as outside. Tire was also checked for proper amount and coating of sealant.

Even though the cut was larger than 1/4" guarantee, the vehicle was not put into a dangerous situation, such as the tire having a blow-out which is normal for a cut of that size. The tire was also repairable, whereas without ULTRASEAL the casing would have definitely been ruined.

Interior shows star
shaped wound 1" X 1/2"

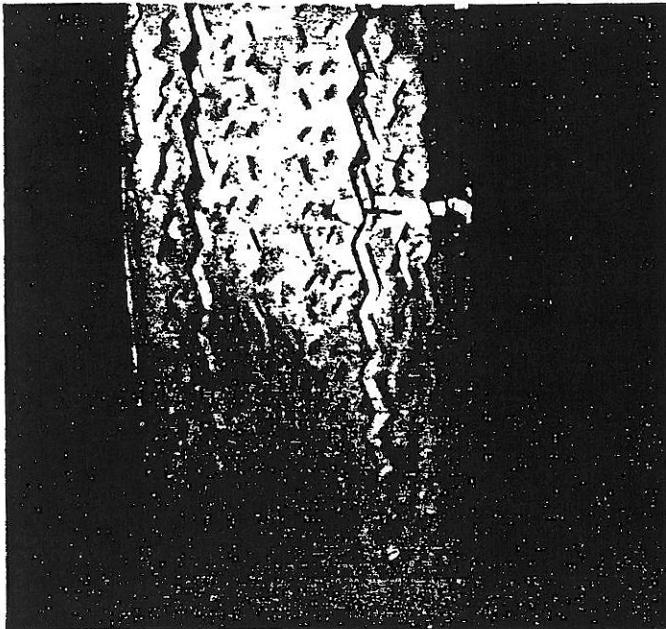
Exterior shows
1 1/2" cut

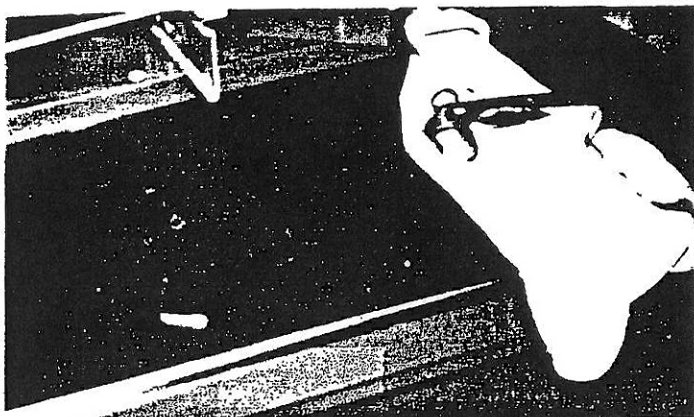
Truck # 2789

Reported flat ready for inspection at Chuck's Tire. It was stated that the nail was observed in the tire on 2/18/83 and 4 days later the tire went flat and was taken to Chuck's for repair. Inspection showed nail puncture in tread area. Tube had been punctured and puncturing object had ripped tube approximately 2" to 3" in length. Also the liner had been torn in half.

Photos indicate puncturing
object and wound in tire

In tube type tires, all puncturing objects must be removed. A routine inspection should be made on tube type tires. Puncturing objects left in the tire will cut and slice the tube beyond repair.

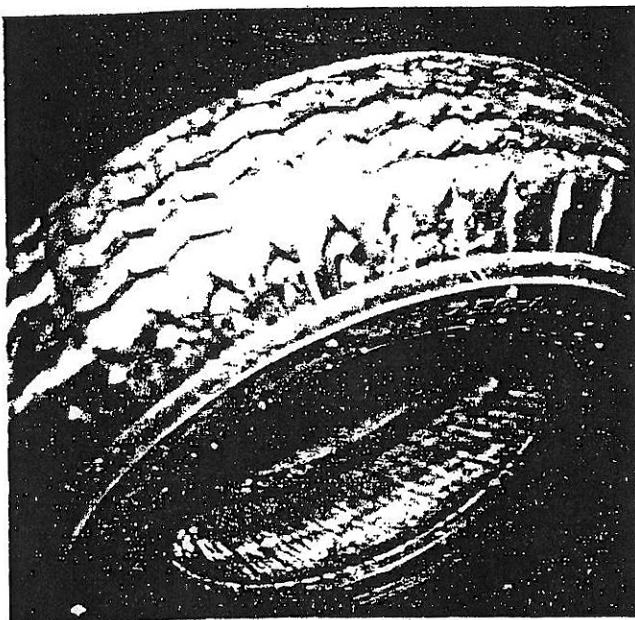
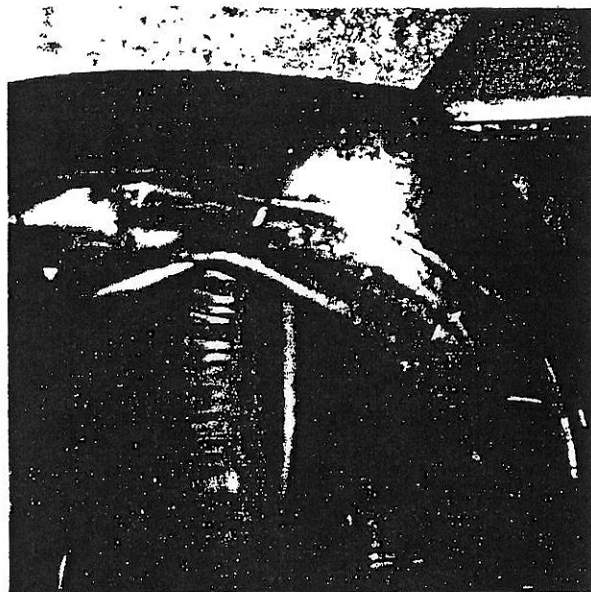
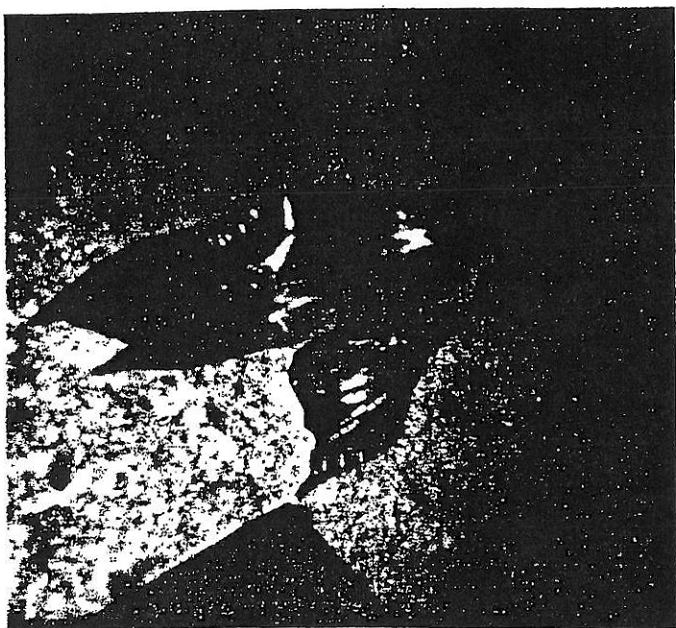
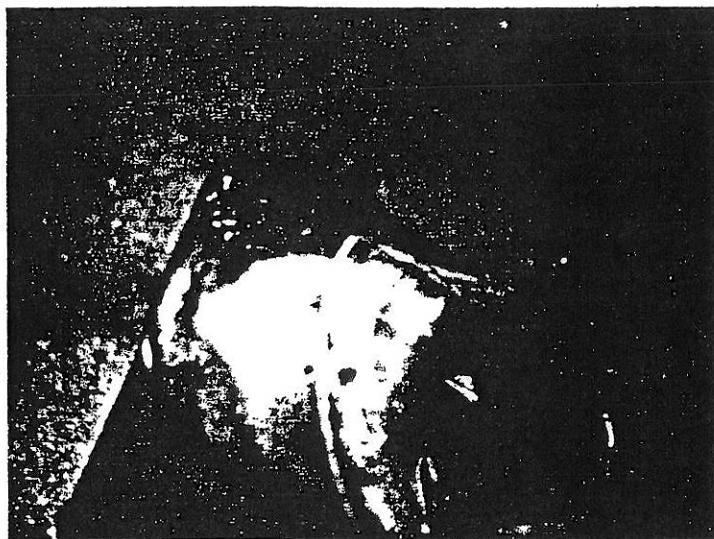
After 4 days of driving
puncturing object tore
tube and liner

Tube and liner damaged
beyond repair

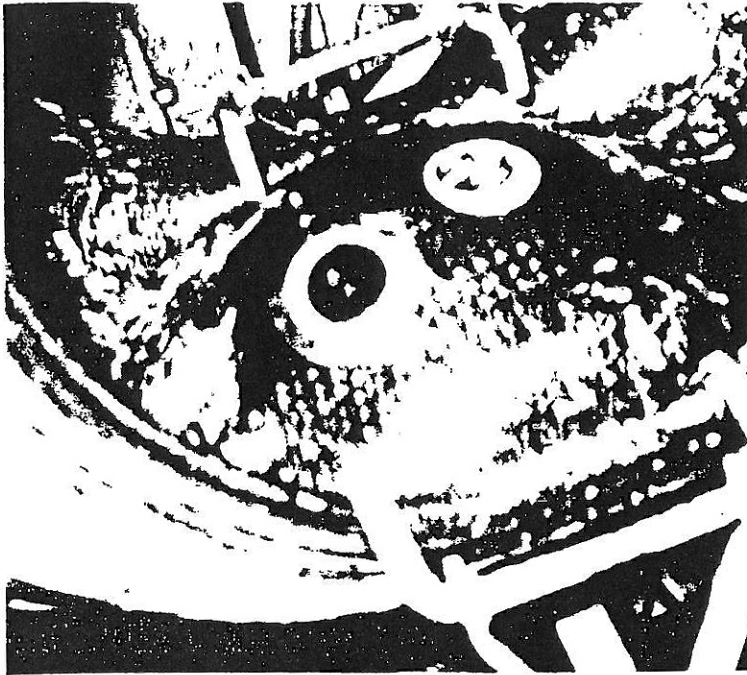
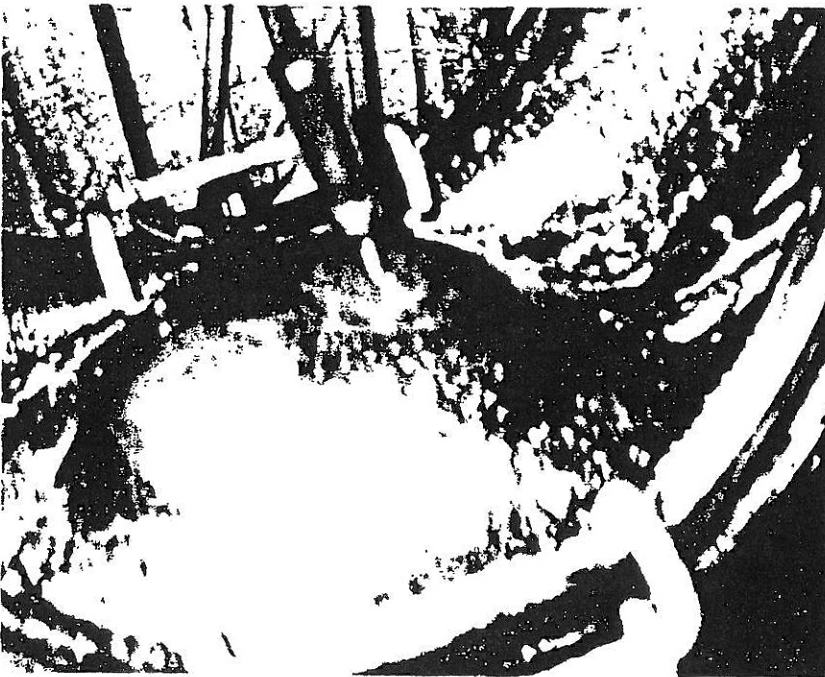
Truck # 4980

Existing patch was removed and the tire cleaned out completely, left un-patched, remounted on wheel and treated with 25 fl.oz. of sealant #58284 (original product). Sealant slowed air loss but would not form a permanent plug. Sealant was removed and sent to laboratory for evaluation. Tire would be examined for broken plies and rubber composition. Product would be checked for fiber content, PH factor, and glycol percentage. Product was unable to form permanent plug because angle of penetration caused a slash-type wound, not allowing product to establish a permanent seal. The tire continued to bleed air as this is what the ULTRASEAL formulation is designed to do. After completion of inspection, patching was performed very easily--no problem in repatching existing wound, nor was there a problem in test patching.

Photos indicate patches installed by Chuck's tire.
Removal of patches revealed one hole completely sealed
by ULTRASEAL and a second hole that was 5/16" to 3/8"
inside.

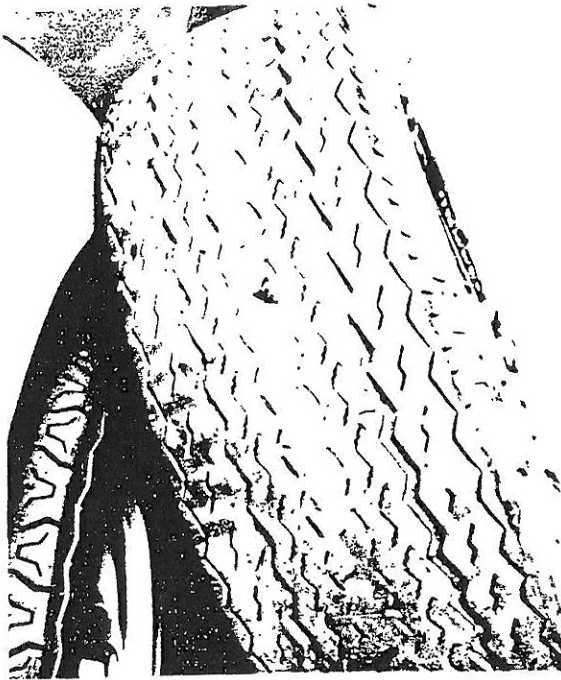
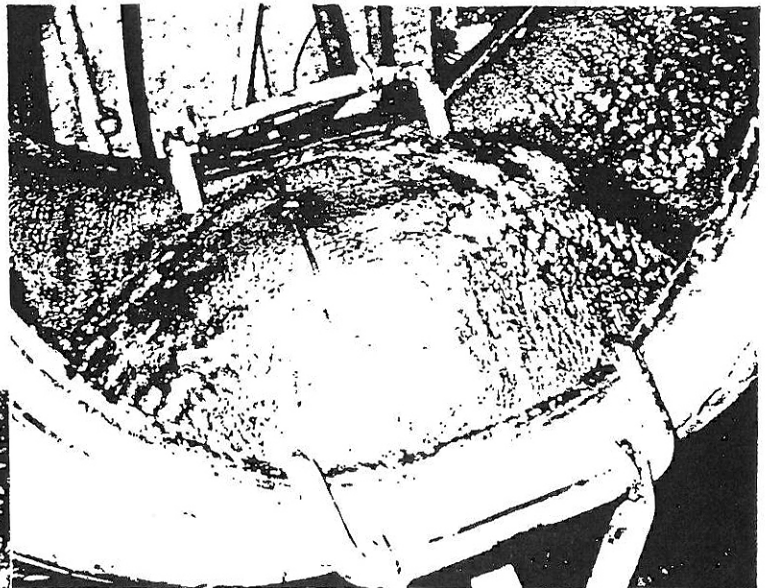
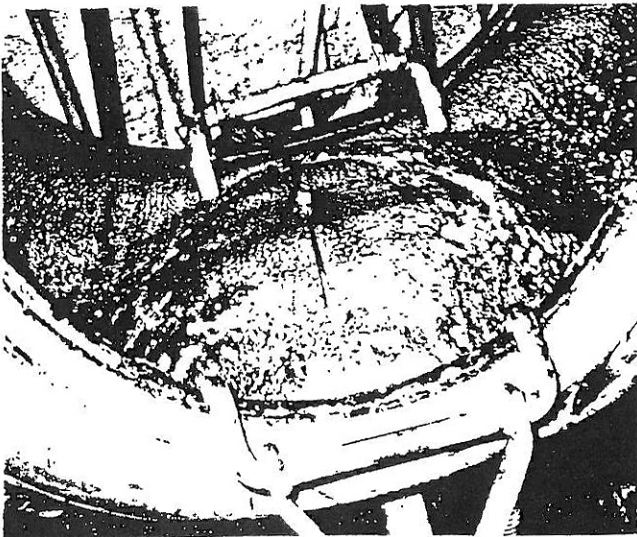
Truck # 4980

Position R/R, mileage 2,350 reported flat. Tire was picked up for inspection. Tire removed from wheel and spread. Wound very large and shaped like figure "X", one side 1/2" to 5/8" in length and other side 1/4" to 3/8" in length. Tire had to be plugged and patched.

The use of ULTRASEAL allowed this vehicle to be driven safely back to yard and tire was repairable--not ruined.

R/R tire exterior photo indicates wound to be 1/2" and 5/8" in and X formation. Interior indicates wound to be 1/4" and 3/8" in an X formation.

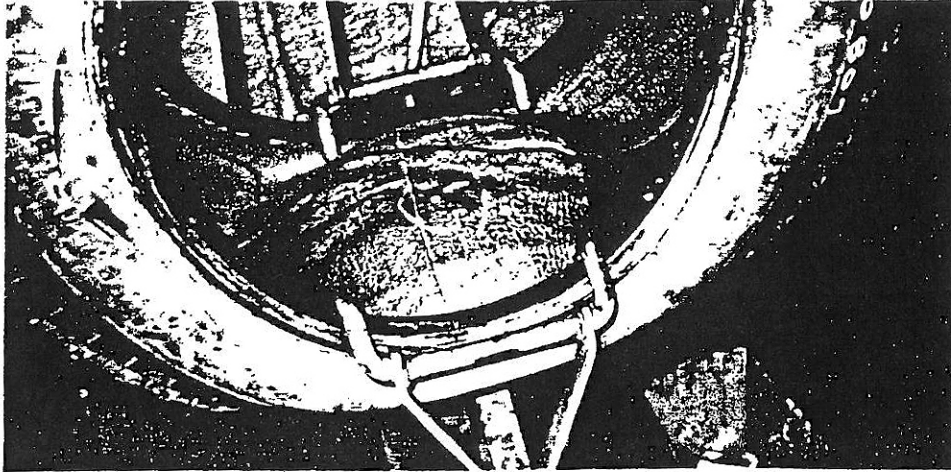
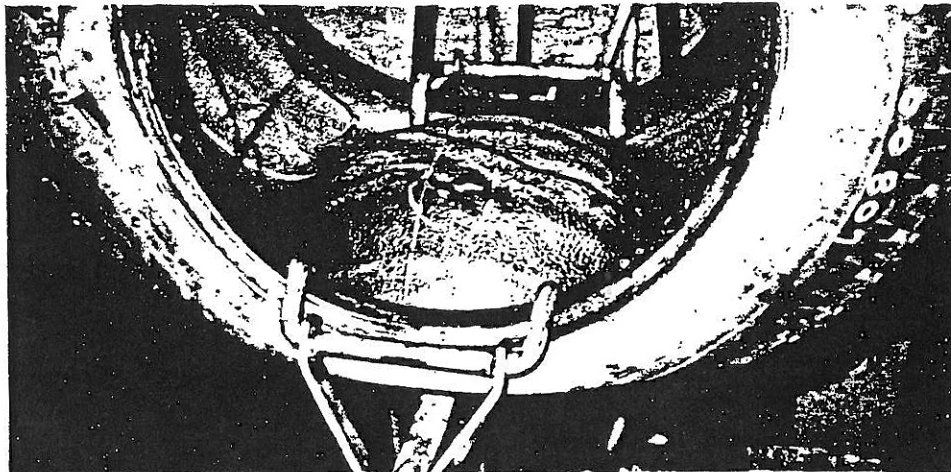
PATCHING PROBLEMS

Tire off Sams truck #4363 was removed from wheel and placed on a spreader. No sealant in tire. It had been completely removed during patching. Inspection showed a large staple in tire tread that had not been removed. Head of staple was completely worn off. ULTRASEAL formed a permanent plug around the staple prongs preventing air loss.

Patching at this time was not a problem. ULTRASEAL had sealed staple puncture even after tire was washed out completely with water. All other punctures that did not seal were larger than 1/4" in diameter and would not fall under guarantee.

Photos reveal staple prongs imbedded on interior of tire. ULTRASEAL completely sealed wound around prongs. Patches in tire were removed. Tire wounds were inspected and tire was completely repatched.

Staple prongs were removed and patching performed. Other patches did not show excessive buffing and punctures they had repaired were all very large in size. Tire was remounted on wheel and treated with 24 fl.oz. of ULTRASEAL, batch #38154 and returned to Cal-Trans.
